# Microsoft Surface Book 2 Teardown

Microsoft Surface Book 2 teardown done on 11/17/2017.

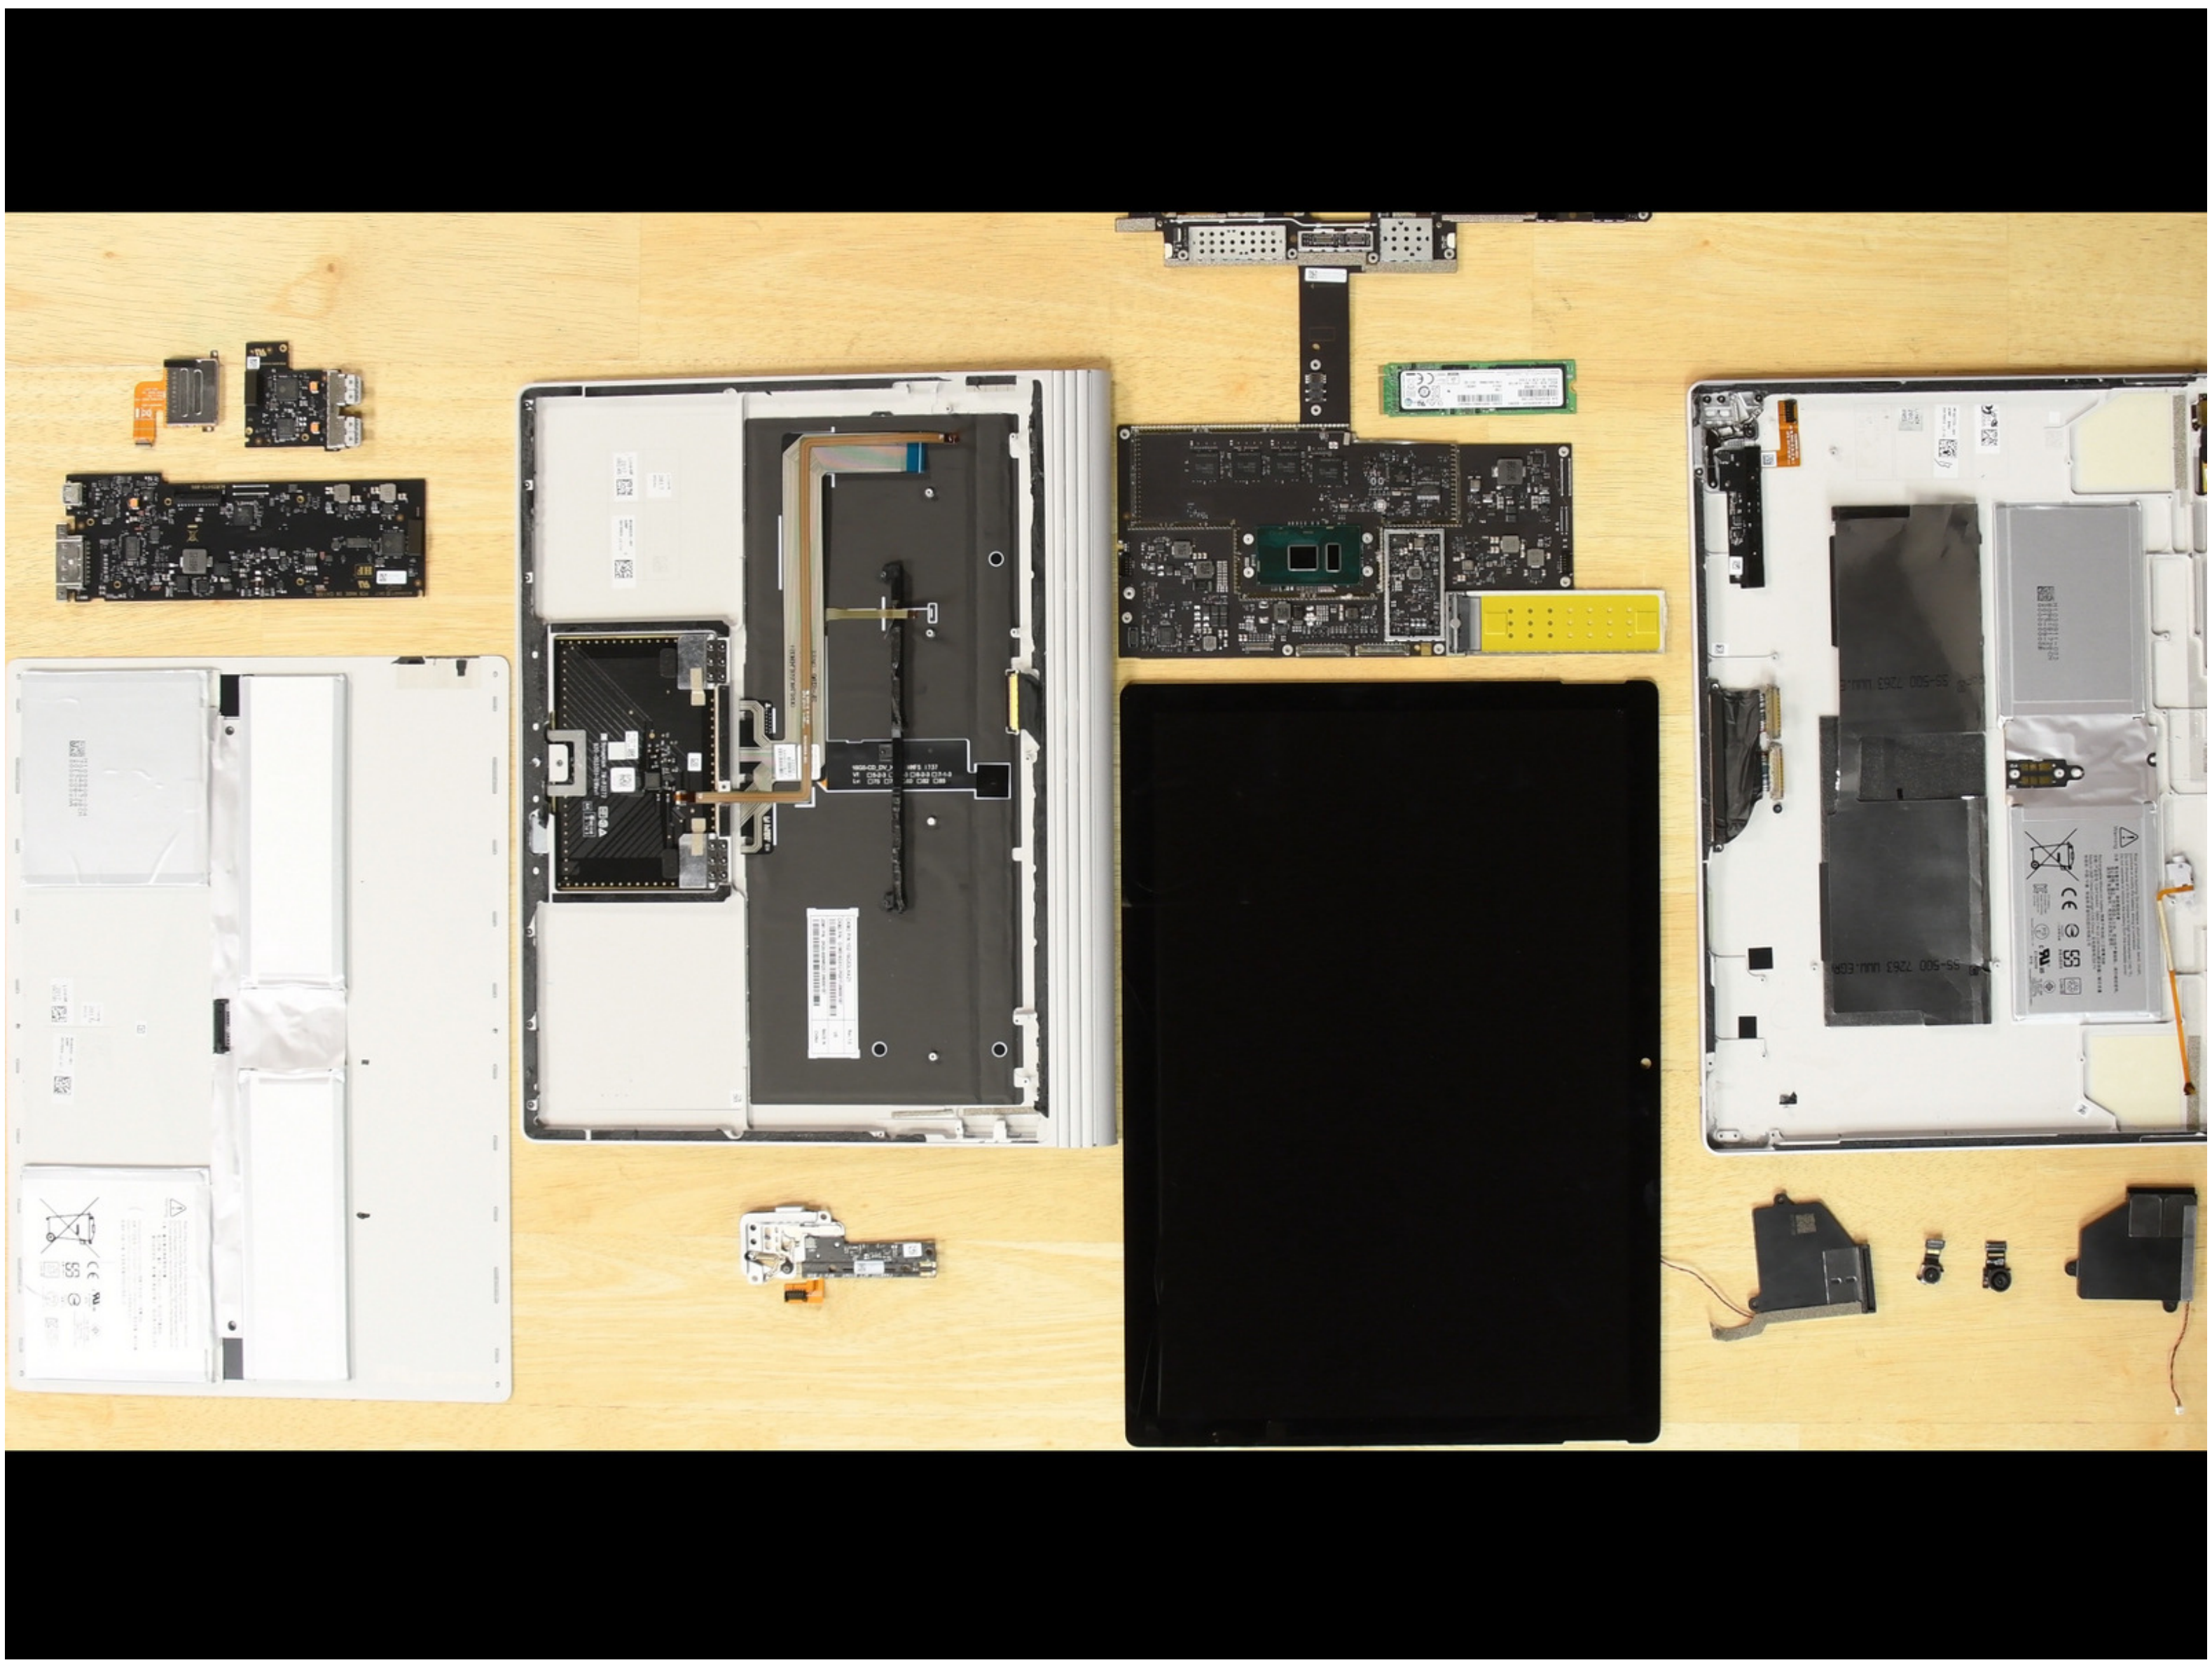
- After the difficult opening procedure, the SSD can be replaced.
- The display assembly consists of a fused glass panel and LCD, and is difficult to remove and replace.
- The processor and RAM are soldered to the motherboard.
- Strong adhesive holds many componets in place, including the display, base cover, and both batteries.
- Many components are on the backs of their respective boards, requiring motherboard removal to replace simple components.
